# THE CORE-LUBE WIRE ROPE RECYCLING LUBRICATOR

A REPORT TO UNOLS

KEN PALFREY, OSU

DECEMBER 1991

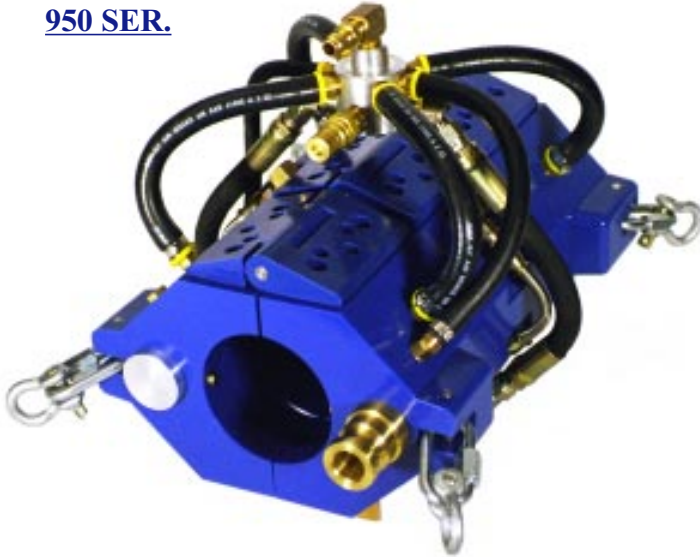
( FIGURE 1 )

Wire rope lubrication is no longer a messy, time consuming task. There is no other system with the versatility and efficiency of the Core-Lube System. The system has proven to penetrate and clean.

- Penetrates lubricant into the wire rope.
- Has (4) injection nozzles for even coverage.
- Eliminates lubricant dripping and fling- off, by air wiping the cable.
- Removes trapped moisture and detrimental particles.
- Continuously circulates & filters gallons of lubricant around the cable under Air & Oil pressure.
- No cable damage due to metal to metal contact with the cable. Uses hard rubber scraper bushings.
- Applies Light to Heavy Gear Oils.
- Quick to rig up.
- Easy to Operate.

The Core-Lube System is manufactured by B&C Wireline Ltd.. This relatively small company specializes in the design of equipment for the petroleum industry. The Core-Lube device has been successfully used on oceanographic wire ropes and EM cables at the Institute of Ocean Sciences, a UNOLS/RVOC member. The Core-Lube System is best described by Figure 1.

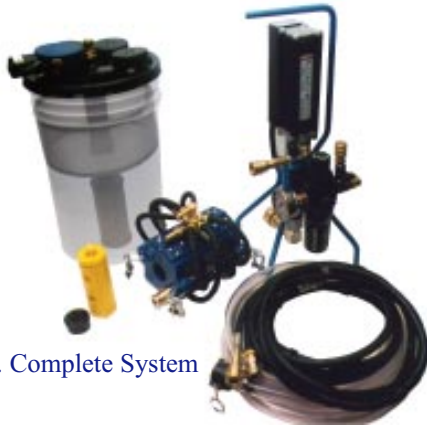
850 Ser. Complete System

# The Core-Lube System offers AIR SEAL Pressure Technology along with high pressure Lubricant Injection @ 3000 psi.

**Core-Lubes patented Air-Seal System ensures that the lubricant remains within the housing thus preventing wastage and environmental contamination.**

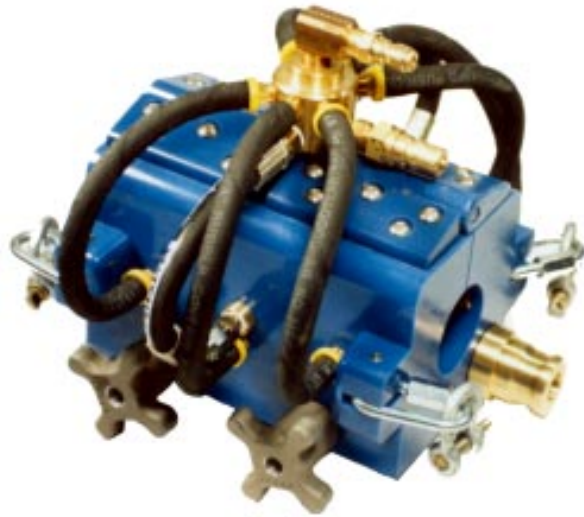
( FIGURE 2 )

The Core-Lube System's primary objective is to penetrate, clean and coat wire rope with lubricant. This is accomplished by circulating lubricant around and through the cable under pressure.

**850 Ser. Cable Capacity:**

Min. Cable Dia. 0.062" ( 1.57 mm)

Max. Cable Dia. 1.680" (42.67 mm)

**Materials:**

Polypropylene, Buna N,  
Polyvinyl-Chloride(PVC),  
Polyurethane, Brass, Copper,  
Stainless Steel

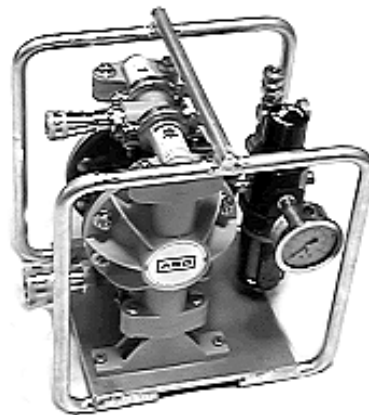
The air capacity required to operate the system will very depending on the diameter of the wire rope or liner size.

For best results 20 cfm (9 dm<sup>3</sup>/s) or more @ 100 psi (690 kPa) is recommended..

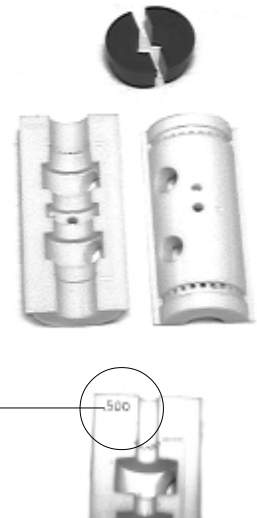
#### Selecting the correct size liner and bushing:

Ideally the Liner & Bushing should match the cable diameter, however a variance in tolerance of 3.0% is acceptable.

The liner size is marked in decimal inches on its inner face.

#### Do not force the liner around a wire rope that is too large.

Both the liner and the bushing fit into dowel pins in the housing. The bushing prevents wear to the liner and should be inserted at the end where the wire rope enters the housing.

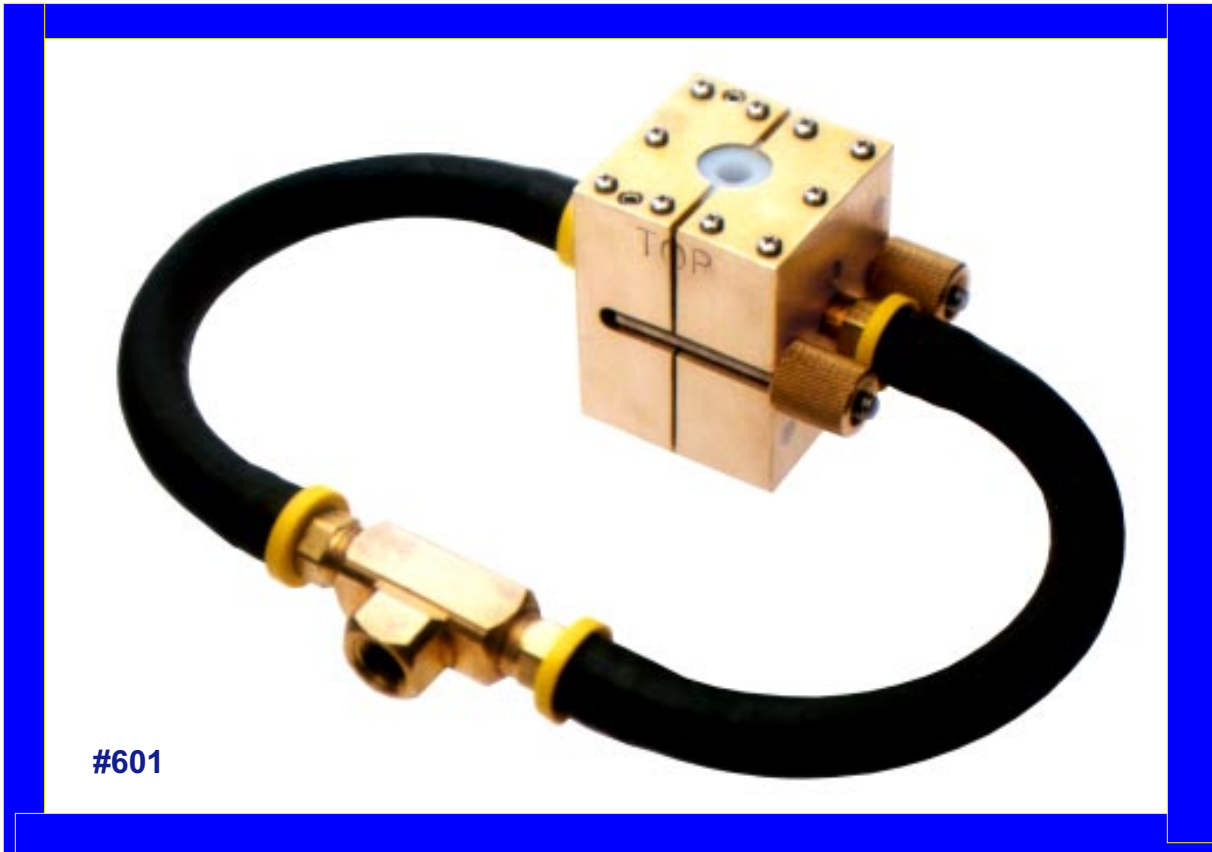
( FIGURE 5 )

# CABLE AIR WIPER

## WIRELINE WIPER DIFFERENCES:

The difference between the Air Wiper and Steam/Water Wiper is the type of hoses, fittings and inserts used.

Replacement inserts are designed for either Air use or Steam/Water use and come in a wide range of sizes.

The main wiper block can be ordered with a variety of options such as Air Hoses, Steam Hoses, Mounting Disk, Couplers, Swivels, etc... See Parts & Price List for more information.

4. If a pressure washer is used to pre-clean a wire rope it should be dried before attempting to apply water-soluble "Pre-Lube 19". B&C Wireline also manufactures a "Cable Air Drier Unit" which removes water from wire rope by compressed air which sells for under \$500.00 see (Figure 5). OSU has purchased one for installation in R/V WECOMA's 1/2" wire train. This device can be used in tandem with the "Core-Lube System" as a dryer. The BOT system also has an effective air dryer section.

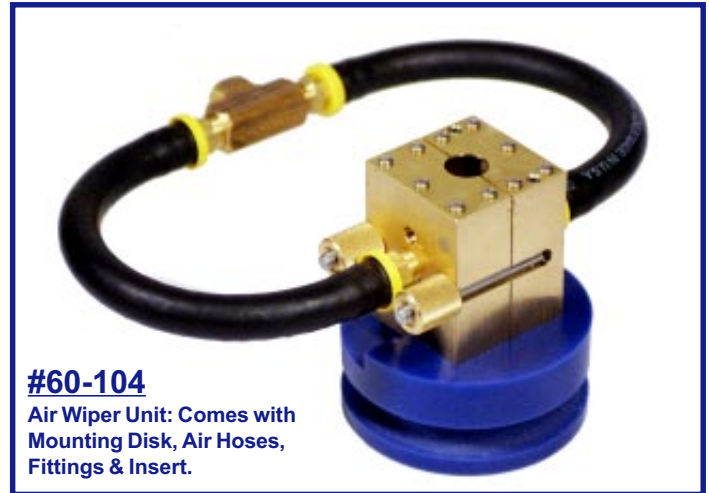
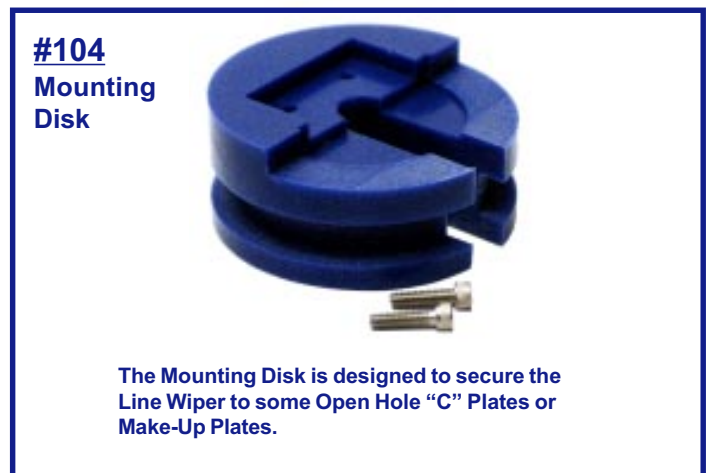
# CABLE AIR WIPER EQUIPMENT

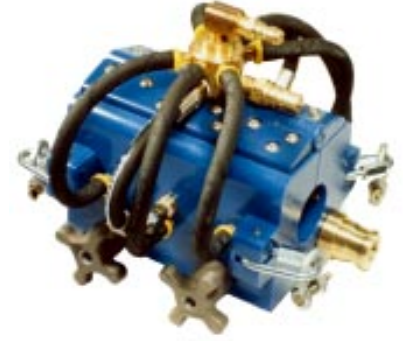
# ( FIGURE 6 )

## CABLE OILER PRESSURE WASHER & AIR DRIER

The Core-Lube System comes complete with hoses with quick couplings, containers with filters, chains, shackles, pump and fittings.

6. Further work needs to be done to develop the full potential of the "Core-Lube System" in support of UNOLS vessels. OSU will loan equipment for the cost of shipping and consumables to those institutions willing to report their experiences to UNOLS. ( See New Up-Dates Figures 5 & 6 )

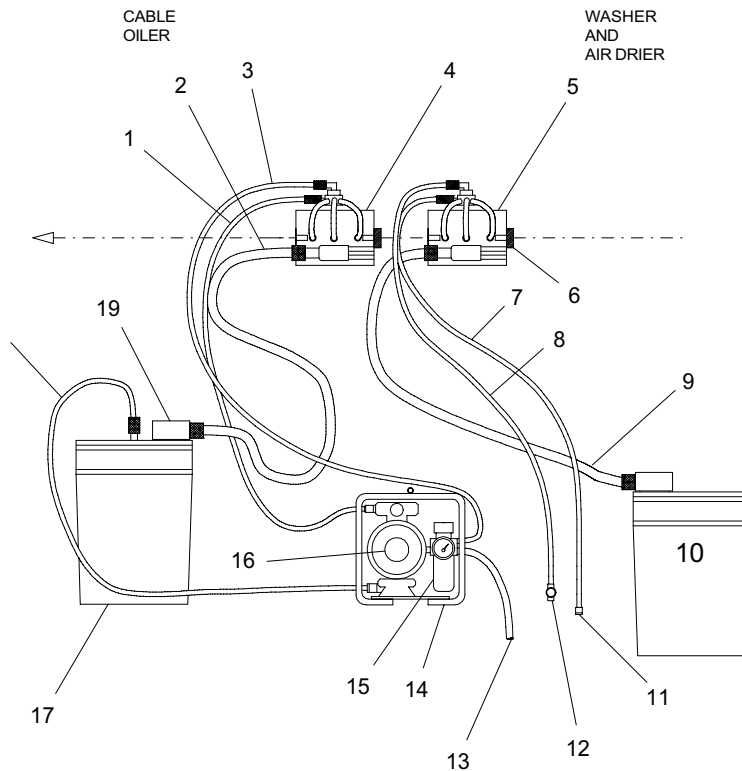
- 1 OIL HOSE WITH QUICK COUPLINGS
- 2 RETURN EXHAUST OIL HOSE WITH QUICK COUPLINGS
- 3 AIR HOSE WITH QUICK COUPLINGS
- 4 OILER HOUSING
- 5 1500 PSI @ 2GAL./MIN. WASHER / AIR DRIER HOUSING
- 6 SCRAPER BUSHING
- 7 1500 PSI WATER HOSE WITH QUICK COUPLINGS
- 8 AIR HOSE WITH QUICK COUPLINGS
- 9 RETURN EXHAUST WATER AND AIR HOSE
- 10 CONTAINER & MANIFOLD
- 11 1/4"NPT FITTING
- 12 1/4"NPT FLOW CONTROL VALVE
- 13 AIR SUPPLY HOSE TO PUMP AND AIR SEALS ( NOT INCLUDED )
- 14 ALUMINIUM CAGE
- 15 AIR REGULATOR TO CONTROL PUMP OUTPUT FLOW
- 16 ARO PUMP
- 17 5 GAL. CONTAINER WITH FILTERS
- 18 SUCTION HOSE WITH QUICK COUPLINGS
- 19 EXHAUST MANIFOLD

3. B&C Wireline Ltd. reports the same lubricator housing can be used as a effective cable pressure washer unit, with a built in cable drier. ( See Figure 1A Up-Date ) The BOT Cable Maintenance system remains a highly effective wire rope and cable cleaner.

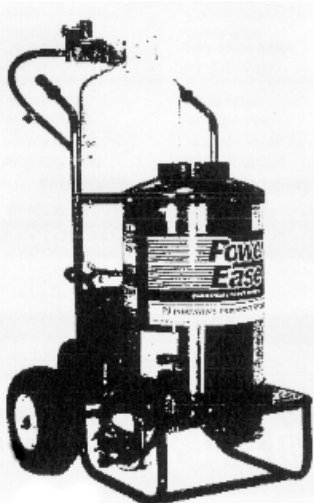
**POWER EASE HOT WATER  
PRESSURE CLEANER  
Model: HW-1520EA1 DIESEL**

2.2 Gal./Min. water  
Operating Pressure: 1500 Psi  
150,000 BTU Input  
115/230VAC - 1PH -- HP2.0

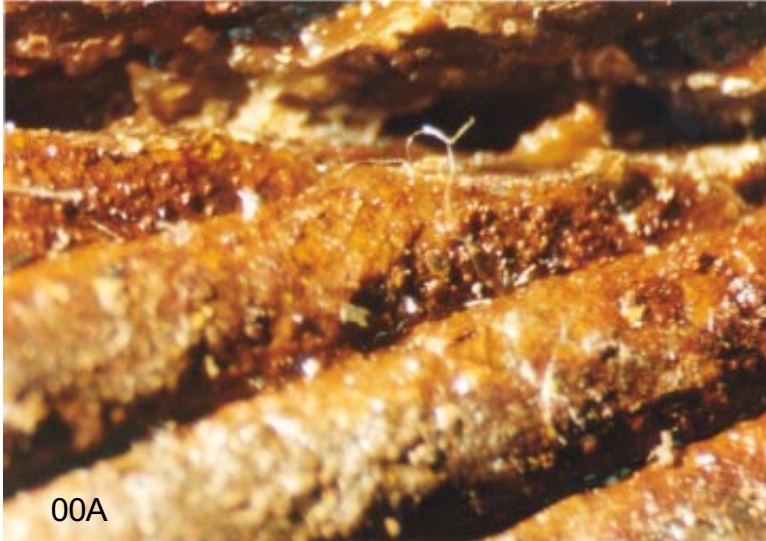
(Photo 00A)

Outside Surface of 3 x 19 Wire Rope:

Individual Wires are 0.060" in Diameter. Glazed material Pre-Lube 19

Magnified 17.5 X  
Stereo Microscope Film, Kodak Gold  
ASA 200 Daylight Exposure 5 sec.

This illustrates the complete "lack—up" of the individual armor wires due to debris. The flat "mushroom shape an the wire behind the whiter thread that looks like a whale tail is rust/ lubricant where a wire laid.

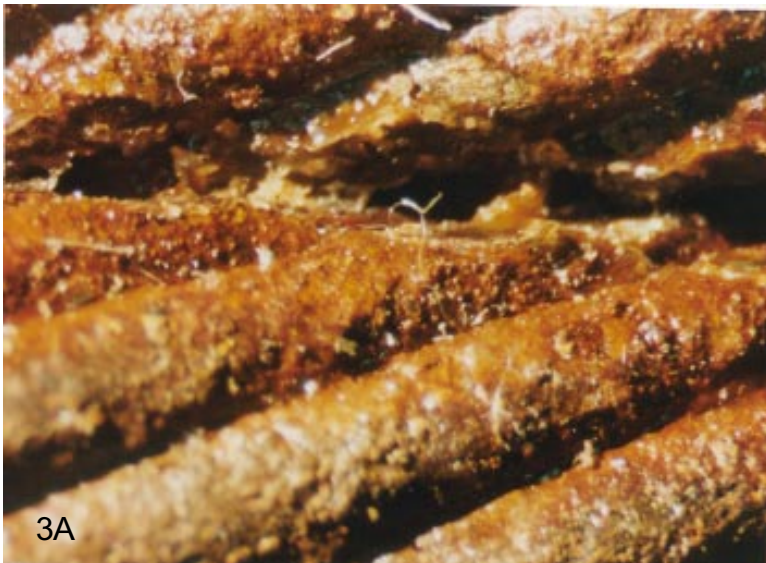
(Photo 3A)

Outside Surface of 3 x 19 Wire Rope:

Same as above but reduced in magnification to 12.5 times.

Lubrication was done on 22 August 1991 and the dissection was done on 26 September 1991.

Partially shows two of the 3 X bundles and where they bear upon each other. This is the flat "mushroom" shaped depression behind the white whales tail shaped thread in the middle of the photo.

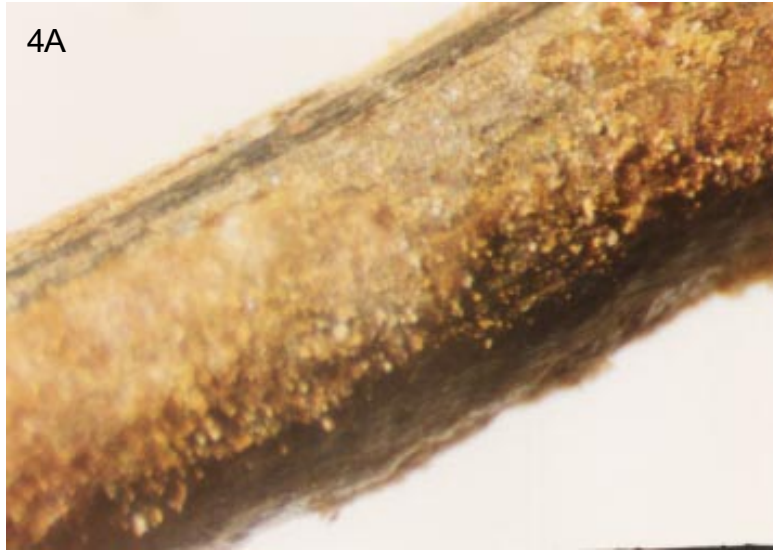
(Photo 4A)

Outer Bundle Wire:  
0.058"- 0.060" OD.

Individual wire as shown in photos  
00A & 3A.

Nine (9) such wires around each  
bundle of the 3 x 19 wire rope.

Magnified 32.5 times

This outer armor wire, separated  
from the bundle shows lubricant  
totally around the wire after re-  
moval. This wire (typ. of 9) lays on  
top of an inner layer of 9 smaller  
wires. Debris sealed the inter-  
stices.

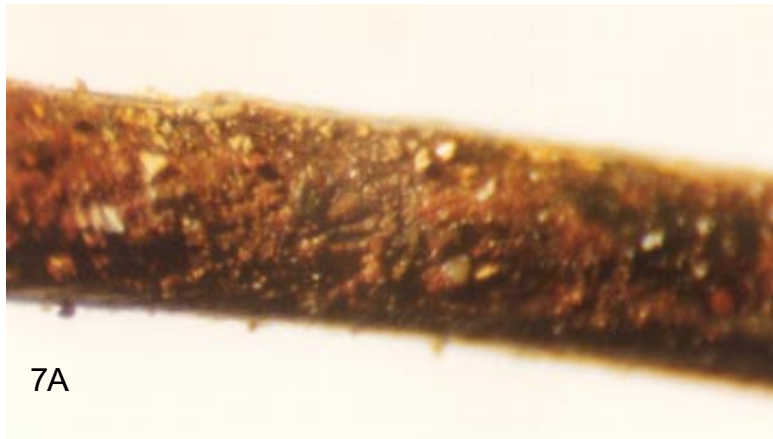
(Photo 7A)

Inner Bundle Wire: 0.034"- 0.035"  
OD.

Typical of 9 such wires around  
inner king wire.

Magnified 32.5 times

The inner nine armor wires around the king wire were totally covered with liquid lubricant upon initial dissection (after 1 month). Smelled of Linseed Oil (Pre-Lube 19) & set-up (gummy) after (1) day exposure (air).

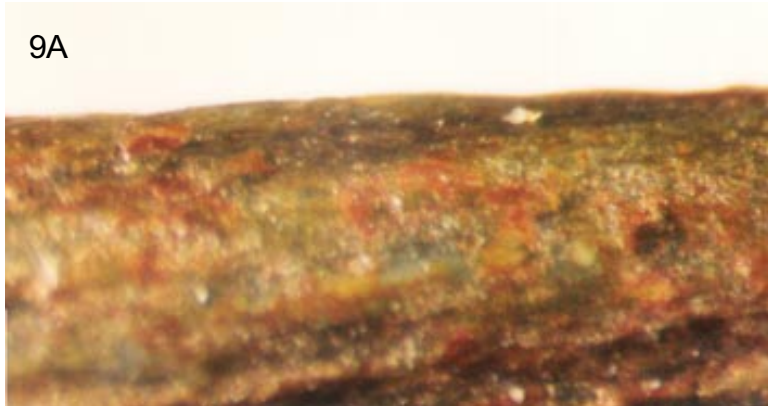
(Photo 9A)

Central King Wire:  
0.069 - 0.011 OD.

One center wire from one of the  
three bundles (3 x 19 wire rope.)

Magnified 32.5 times

The central king wire was wet with  
lubricant upon dissection & had  
the linseed oil smell of Pre-Lube  
19. Black/Brown corrosion on the  
surface interstices with upper layer  
of armor completely blocked with  
debris.

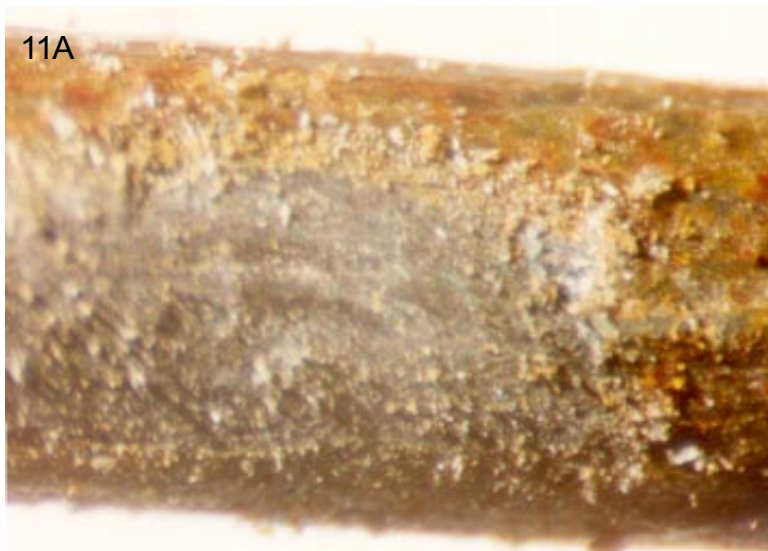
(Photo 11A)

Central King Wire:  
0.069" - 0.070" OD.

No Galvanizing.

Magnified 32.5 X

Dark area is steel.

Shows king wire after scraping with a knife. Iron oxides mixed with "gummy" lubricant. Black stain/coating on wire possibly zinc & iron oxides. Some pitting 0.003" deep, at most on king wire.

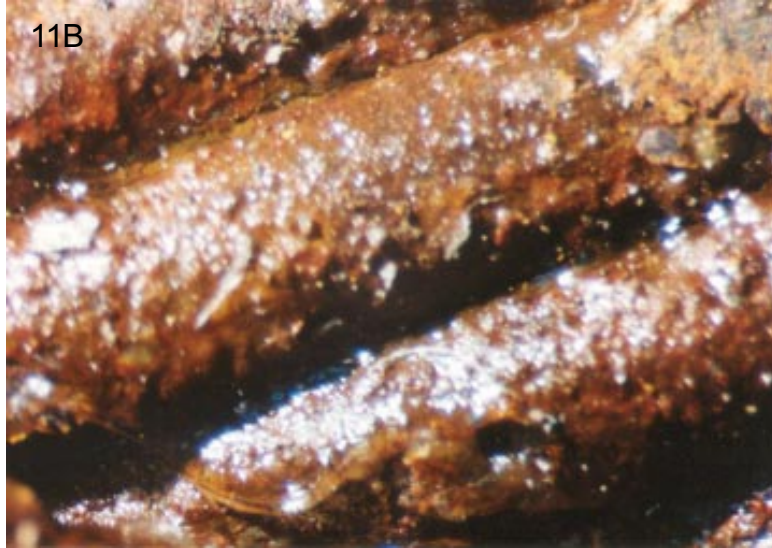
(Photo 11B)

Outer Bundle Wires: (0.070" OD)

Another View

Magnified 20 times

Showing the debris lock-up between armor wires. What appears as white powder are specular reflections from point sources of light in this time exposure. One salt crystal appears on the left, middle of photo.

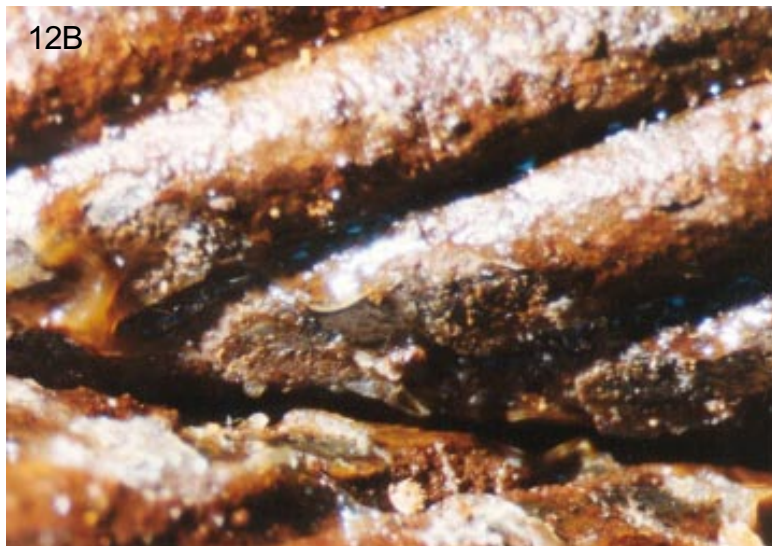
(Photo 12B)

Outer Bundle Wires: (0.070" OD)

Showing Space Between Two Adjacent Bundles.

Magnified 35 times

This view shows the spots where the third (and missing) bundle lay across the other two bundles. The "mushroom" debris can be seen surrounded by lubricant. A piece of "gummy" lubricant can be seen on the left, middle.

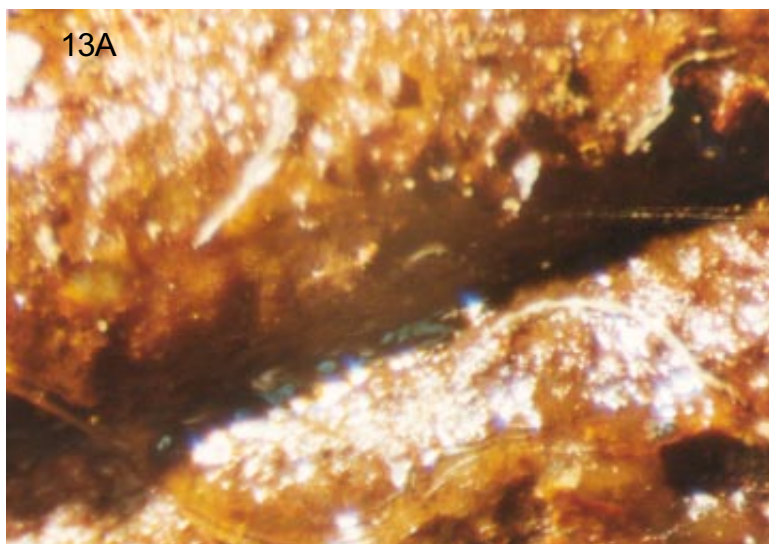
(Photo 13A)

Outer Bundle Wires (0.060" OD)

Magnified 35 X

Another section of the outer bundle wires (0.060" OD) showing the complete lock-up between wires by debris and corrosion products. These products were not analyzed but appear to be ferrous and ferric oxide and zinc oxide (a white powder's been observed that's not salt crystals).

The small white spots in this photo are specular reflections from clear or crystalline material due to the long exposure times. Some bits of debris (upper left corner) are re-crystallized salts from the seawater. The glazed, caramel-looking objects are polymerized pieces of Pre-Lube.

During dissection, at those cross-over points where one wire would bear on another wire, a bright, shiny spot was observed with Pre-Lube 19 both surrounding the spot and on the spot. These were the areas referred to as "mushrooms". These spots, more than any other areas showed that lubricant stopped the oxidation process for the month period from when lubrication was performed and when the dissection occurred.
